Intrusion Detection & Oil Condition Monitoring: A Paper Industry Pilot Program

by Dan Edney, PhD & Sam Jones, IntelliStick Inc.

PILOT PROGRAM INSTALLATIONS

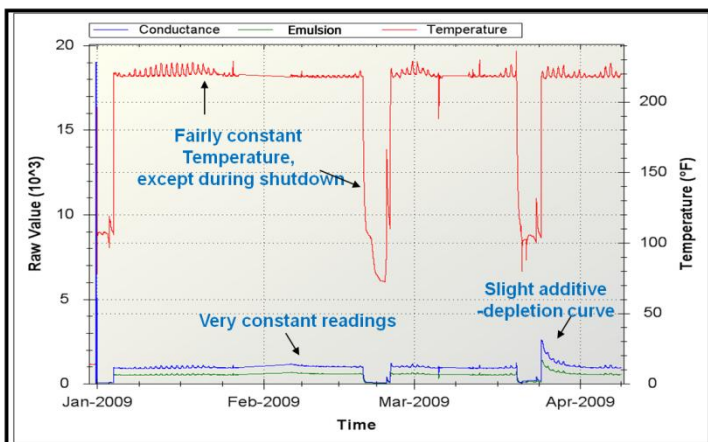
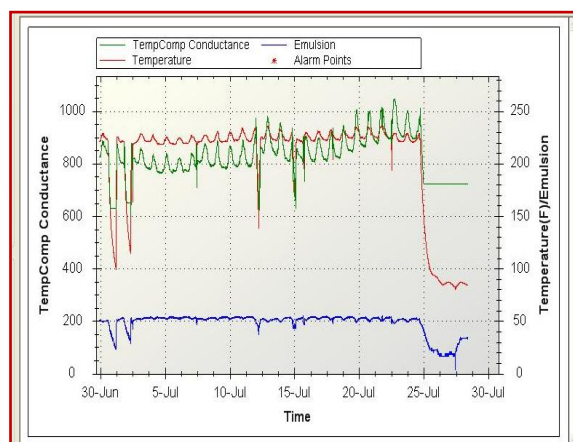
Fig 4: Cogen Data Example A—raw data

Fig 5: Cogen Data Example B processed data over 1 month

[Figure 4 and Figure 5] No raised emulsion reading indicates that there is no water in the oil. No upwards slope on the conductance means no oxidation. The slight additive-depletion curve (noted Fig.4; 16 Mar) follows an oil change or large top-off. The renewed additive package declined relatively quickly over the following week.

The COGEN data has been highly consistent throughout the program period, showing only slight variations in temperature and oil condition. There has been no indication of water or other intrusion. The automatic top-off with fresh oil results in only minor changes in additive level, and consequently normal data produces a relatively flat graph. Many of the minor variations in the reading relate to large temperature changes during startup and shutdowns.

Data vs. Lab Reports: Oil sample analysis reports from 23 Jan, 23 Feb and 19 Mar confirmed normal operations—the Total Acid Number (TAN) was not significantly elevated in any sample compared to the Total Base Number (TBN), no water or other contaminants were detected in the oil, and the level of metals in the oil was low.

This supports the conclusion from the IntelliStick data that everything is normal. Of note, while IntelliStick monitoring is continuous and real time, a typical lab analysis interval, between sample and report, was about 8-12 days.

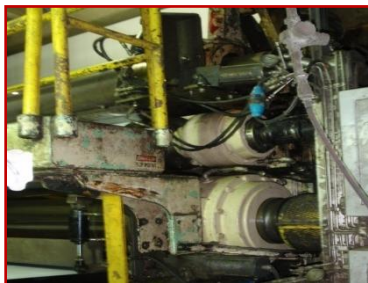
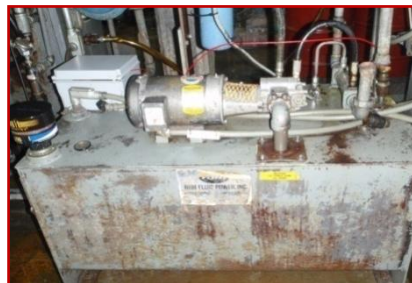
Fig 6: GPI CC Stack

Fig 7: GPI CC Stack Reservoir

Equipment: Controlled Crown Stack Bearing lubrication 300 gal Reservoir

This application point was initially thought to be a good application test site as it is habitually prone to water contamination. The oil separates well in the reservoir, and water is routinely drained from the bottom and oil is added to the top of the reservoir. The system also tends to leak oil around the stack. Because water was separated from oil and not a lot of turbulence, the probe was extended to near the bottom of tank. Normal operating temperature: 145 degrees F; Flow to bearings 10-12 GPM.

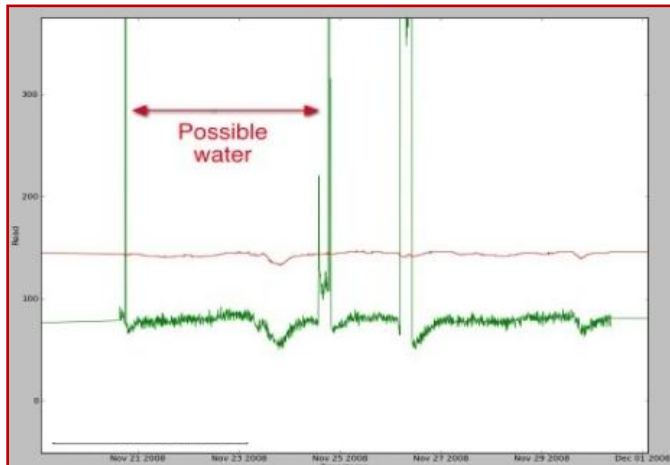
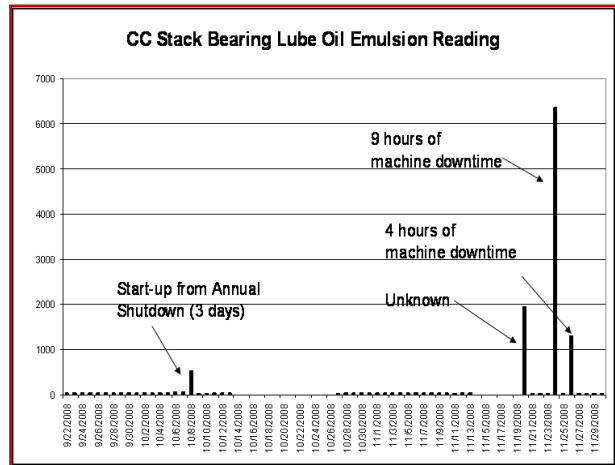
Fig 10: Emulsion reading - CC Stack Example

Fig 11: Emulsion reading - CC Stack Data (Excel graph)

[Figure 10 and Figure 11] The emulsion number only became elevated at startups. It is believed this is because startup was the only time when there was enough turbulence in the reservoir for emulsified water to become mixed throughout the oil reservoir. This highlights a feature of the IntelliStick system: the water must be emulsified into the oil to be detected. Un-emulsified water that sits at the bottom of the reservoir is not a risk to the equipment.

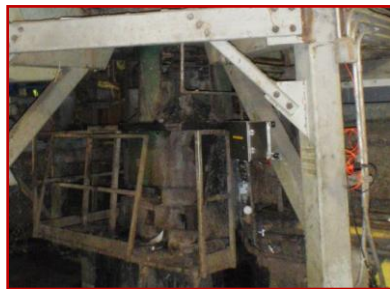
Fig 12: OCC Pulper Gearbox

Equipment: Black Clawson #4 Gearbox for 20 ft OCC Pulper

This air-cooled system is one of the biggest gearboxes in this facility and has been prone to water intrusion in the past. The gearbox uses a non-synthetic 320 grade oil, which historically was changed on 3-month and 6-month PM cycles. Currently oil is changed on an as-needed basis, based on visual inspection.

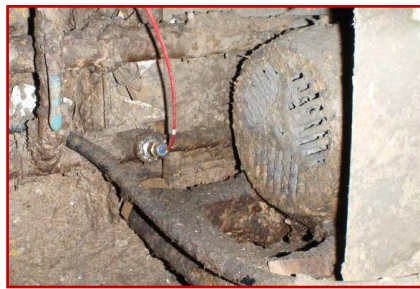
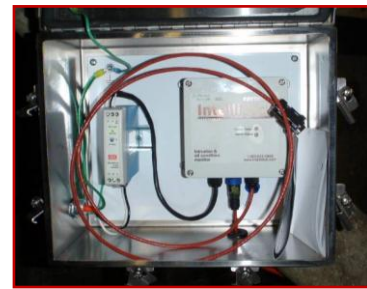
Fig 13: Threaded Sensor detail

Fig 14: Installation detail

Installation: The Industrial instrument—a new instrument in a new location—was installed in a protective box to keep from being damaged by passing equipment. The ½” NPT Threaded Sensor is located on the discharge of the lubrication pump as it comes out of the gearbox before filtering and cooling.

The one drawback of this installation is that the LED alarm lights cannot be seen; the alarm information, such as intrusion detection, needs to be communicated through the plant monitoring system without reliance on the visual LED in the case. The system was installed on February 27th.

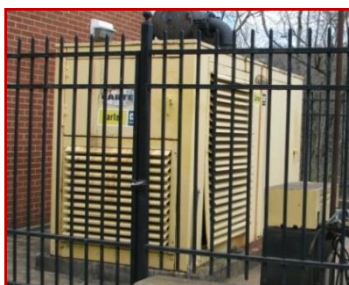
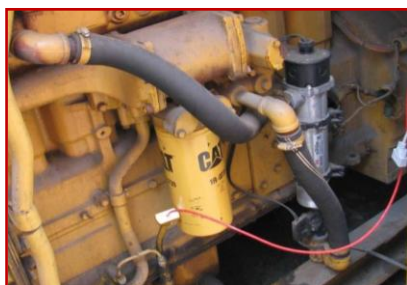
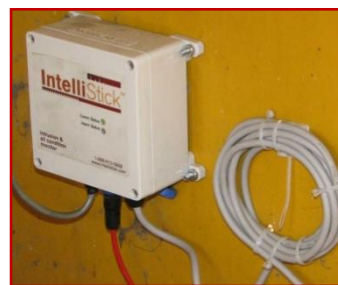
Fig 16: Standby Generator

Fig 17: Dipstick Sensor detail

Fig 18: Analyzer Installation detail

Equipment: Caterpillar Diesel Generator

This standby generator is a critical piece of equipment used as backup power for effluent pumps. The loss of city power could result in a mill shut-down. The city previously owned and maintained the equipment, but never ran it. They reportedly paid about \$2,000 per year for oil tests and changes. Normally the generator runs for a minimum of about 2 hours per week.

Hurdles/Issues: IntelliStick unit is installed using a dipstick sensor that accesses the oil via the dip tube. At the time of this report, however, the transfer switch from city power was not in service and the generator was temporarily out of service. Accordingly, no data was available during the period of the pilot program.

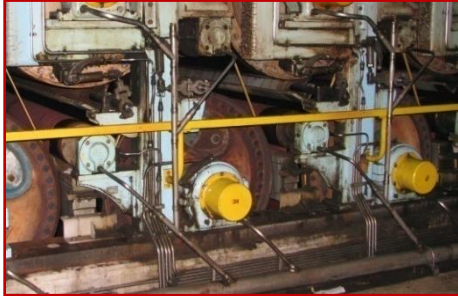
Fig 19: Gravity lubrication illustration

Equipment: 2,000 gallon Oil Reservoir Wet End Lubrication System

This lubrication system serves the main paper machine. A gravity feed pipe, with a slope of .5 in/10 ft., is known to have water contamination, and has a flow rate of 10 gpm.

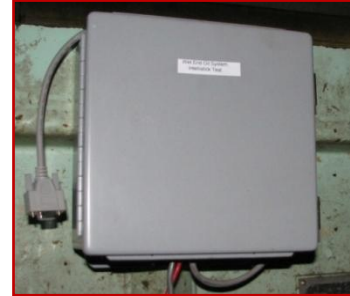
Fig 20: Threaded Sensor installation detail

Fig 21: Wet End installation detail

Installation: The installation of the threaded sensor was accomplished by a 4" pipe cut and nipple welded onto bottom of pipe [Fig. 20]. This may not be an ideal mounting location because it is picking up bulk water in the bottom of the pipe. A possible relocation is under consideration. This demonstrates that sensor installation location is important for obtaining a good sample, because the state of the water in the oil varies significantly according to turbulence and mixing conditions.

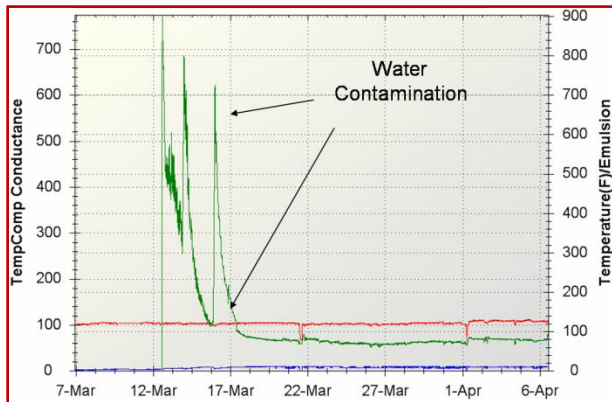
Fig 22: Wet End Data Example

[Figure 22] The fluid temperature operates at about 100F constantly. The conductance readings fluctuate significantly, possibly indicating that the water was not emulsified into the oil, but existed as large discrete droplets. After 18MAR, readings become flat indicating that water was no longer present in the same way.

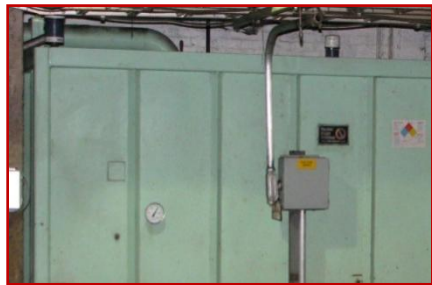
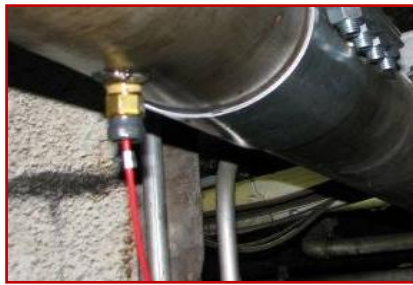
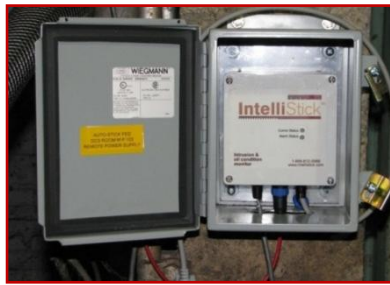
Fig 23: Dry End Reservoir

Fig 24: Threaded Sensor installation detail

Fig 25: Dry End installation detail

Equipment: 5,000 gallon Oil Reservoir Dry End Lubrication System

The threaded sensor was installed in a 6" pipe (cut and nipple welded onto bottom of pipe) where the gravity flow rate is about 30 gpm [Fig. 24]. This location is known to have water contamination, and an evaporator was installed at the dry end.
